# UNDERWATER BRIDGE INSPECTION REPORT

STRUCTURE NO. 70002  
CSAH 101  
OVER  
THE MINNESOTA RIVER  
DISTRICT M - SCOTT COUNTY

PREPARED FOR THE  
MINNESOTA DEPARTMENT OF TRANSPORTATION  
BY  
COLLINS ENGINEERS, INC.  
JOB NO. 5221

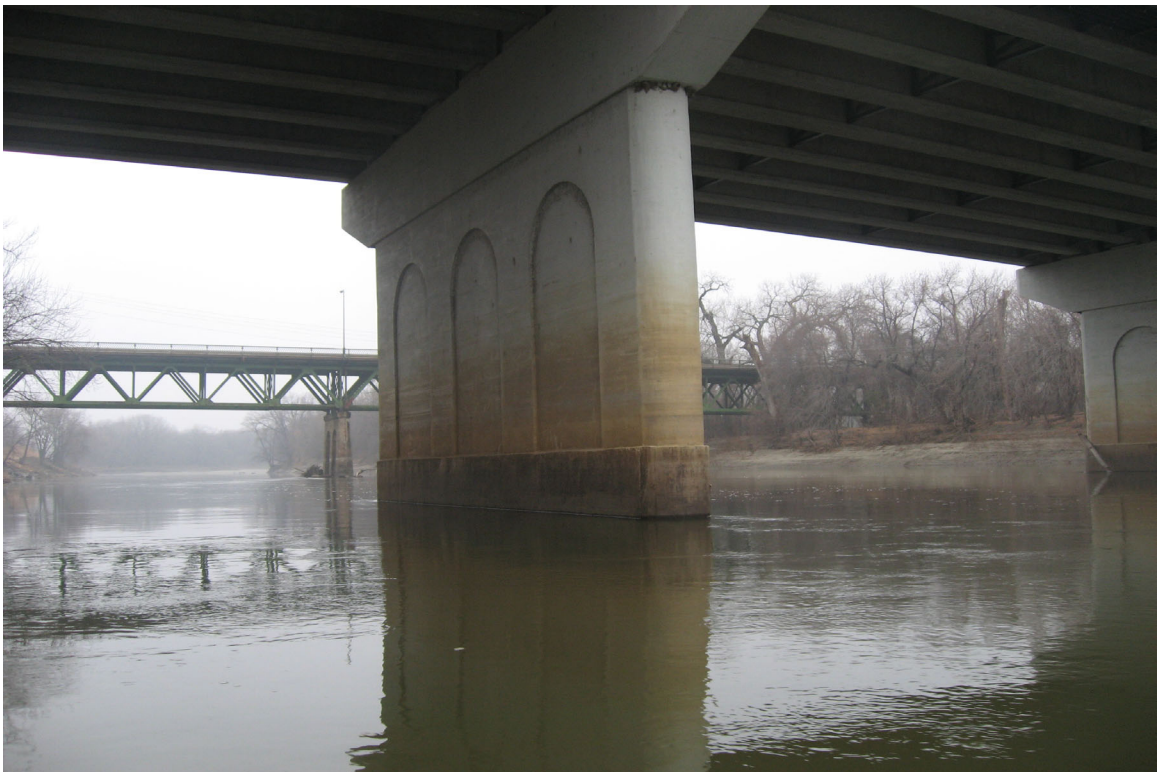
Photograph 2. View of Pier 3, Looking Northwest

- Random vertical cracks were observed from the top of the shaft ledge to the channel bottom with efflorescence. There were typically two cracks on each pier at about the third points with 1/8 inch maximum width.

- Moderate to heavy accumulation of timber debris consisting of logs and branches 12 to 15 inches in diameter and smaller was observed along the south face, around the upstream nose and to about the midpoint on the north face of Pier 3 extending from the waterline to the channel bottom.

- (A) Monitor the timber debris at the piers, and if found to be increasing in the future, removal operations may become warranted.
- (B) Reinspect the submerged substructure units at the normal maximum recommended (NBIS) interval of five (5) years.

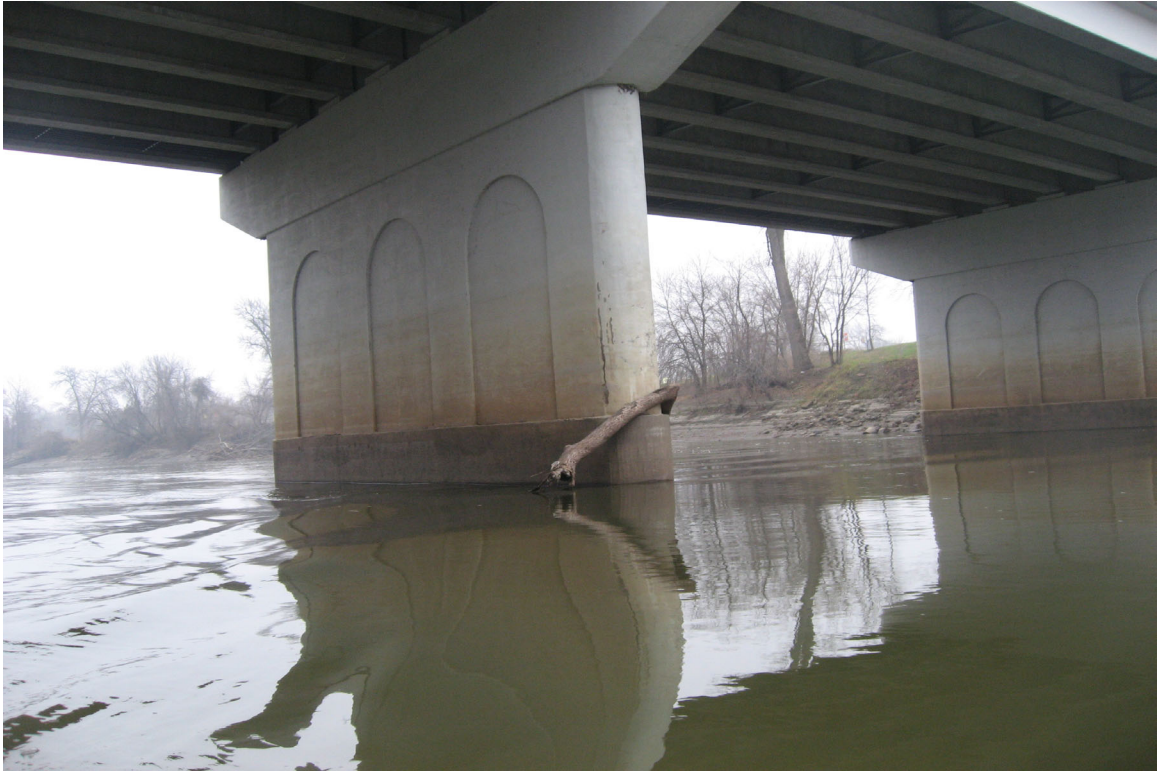
Photograph 3. View of Pier 4 and Timber Debris, Looking Southeast.

- The channel bottom of Pier 4 consisted of silt, gravel, and clay with up to 6 inches of penetration.
- A moderate accumulation of timber debris consisting of 12 inch diameter and smaller logs and branches was observed from the upstream nose to the upstream quarter points on both sides of Pier 4.

- A scour depression 5 feet in radius by 2 feet deep was observed at the upstream end of Pier 4.
- The channel bottom of Pier 5 consisted of clay and silt with 2 to 3 inches of probe rod penetration and also stones 6 inches in diameter located at the upstream end.

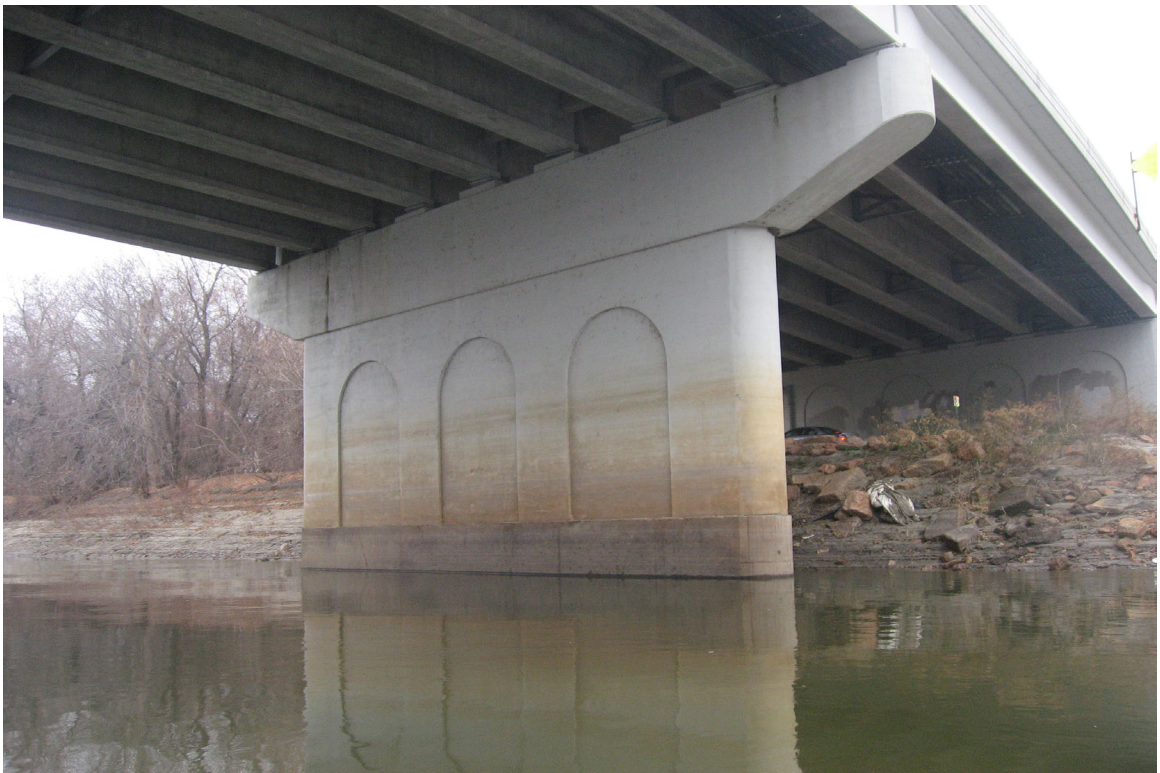
Photograph 4. View of Pier 5, Looking Northwest.

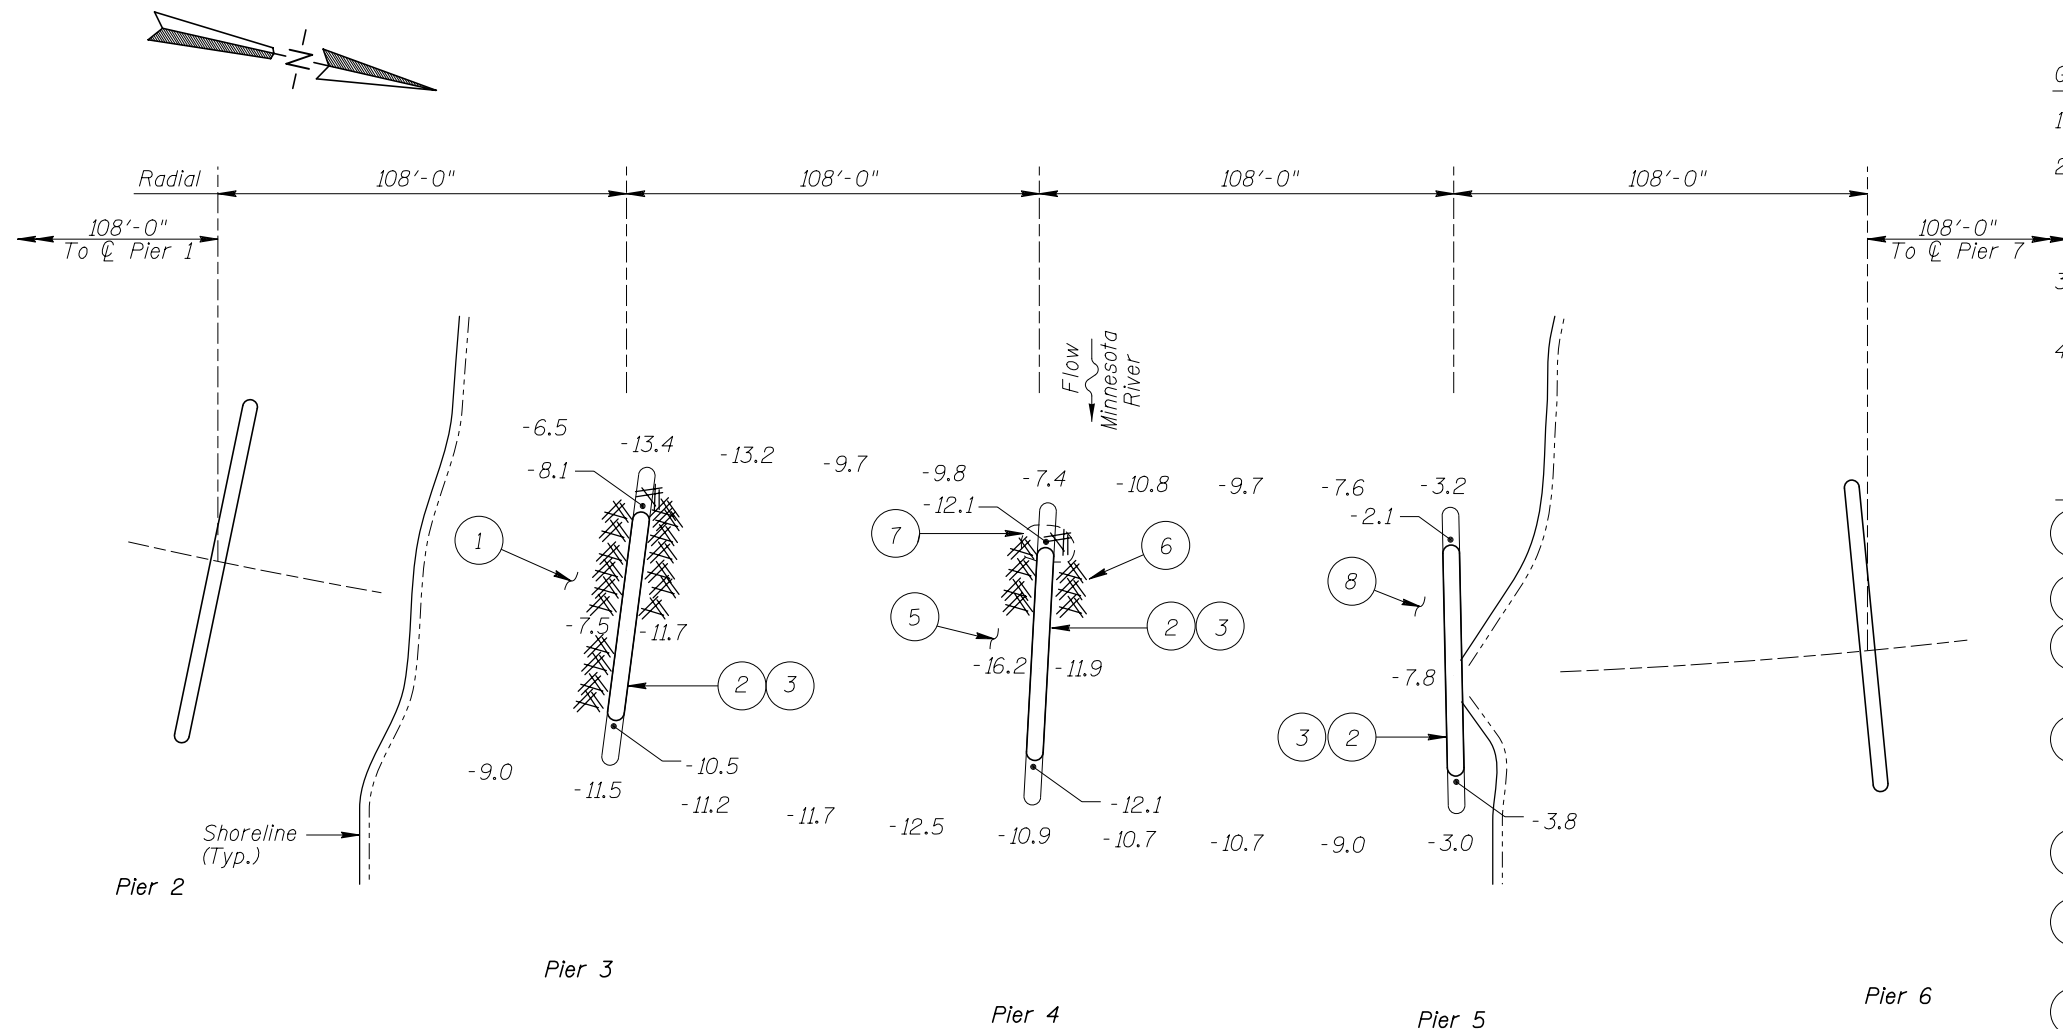
#### INSPECTION AND SOUNDING PLAN

- The channel bottom at Pier 3 consisted of gravel with silt with up to 1 foot of probe rod penetration.
- The concrete was smooth and sound at all of the piers.
